Manhole Inspection Summary

Manhole # S13MM_015MH

Insp Date: **6/24/09 3:12 PM**

Location Address: **ELGIN AVE**

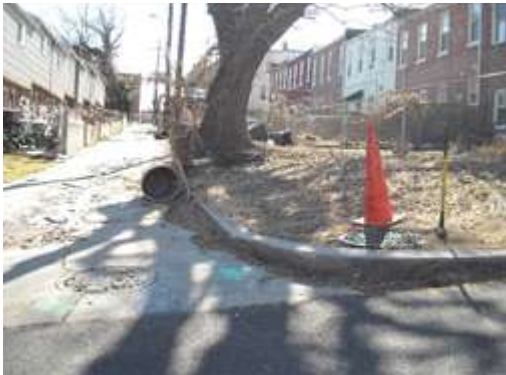
Location View

LOCATED IN GRASS ADJACENT TO
NODE 021

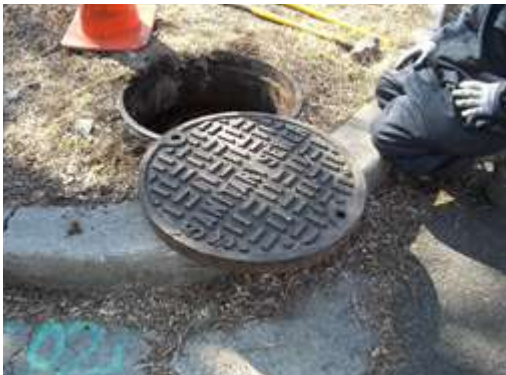
EXISTING LID IS IN GOOD CONDITION

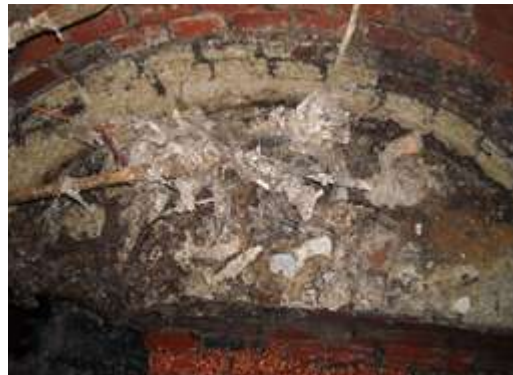
Defect 4

Condition: ☐ Sound ☐ Cracked ☐ Root Intrusion ☐ Deteriorated ☐ Leaks ☒ **Debris**

☒ **Evidence Of Surcharge**

DEBRIS ON BENCH EVIDENCE OF
SURCHARGE ON STEP

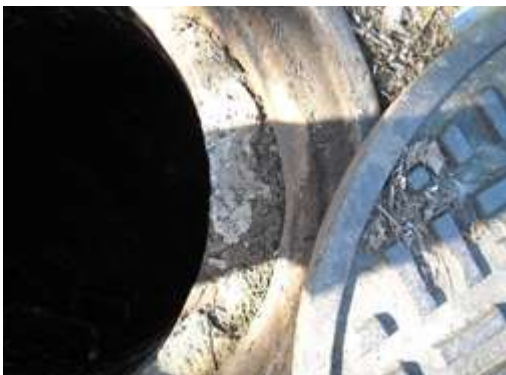
Defect 1

Offset: **3** (in.)

FRAME OFFSET 3"

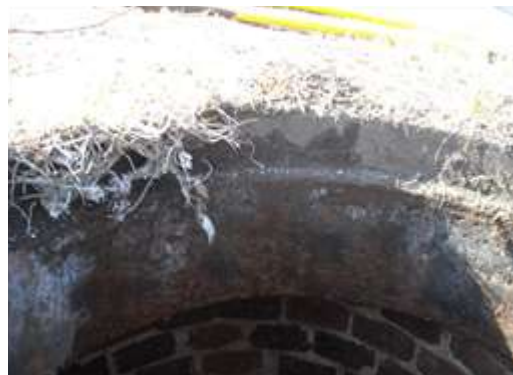
Defect 2

EVIDENCE OF INFLOW DUE TO
SHEETING - GRASS AND SOIL ABOVE
FRAME

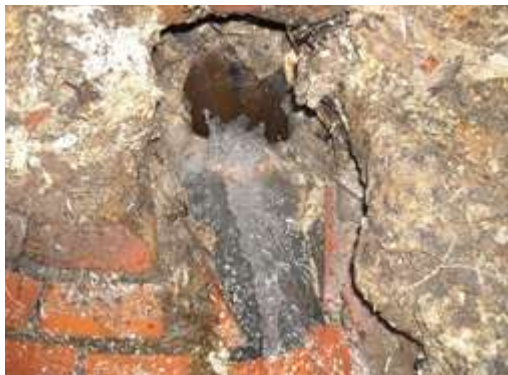
Defect 4

Comments **LOCATED IN GRASS OFF ELGIN AVE. INSPECTION COMPLETE. THE CHANNEL HAS COLLAPSED IN FRONT OF THE 12 OCLOCK CONNECTION - THERE ARE BRICKS MISSING. NEEDS REPAIR.**

Condition: ☐ Sound ☒ **Cracked** ☐ Root Intrusion ☒ **Deteriorated** ☐ Leaks ☐ Debris

ASIDE FROM THE GREASE
EVERYWHERE, THE CHANNEL HAS
COLLAPSED COMPLETELY INFRONT

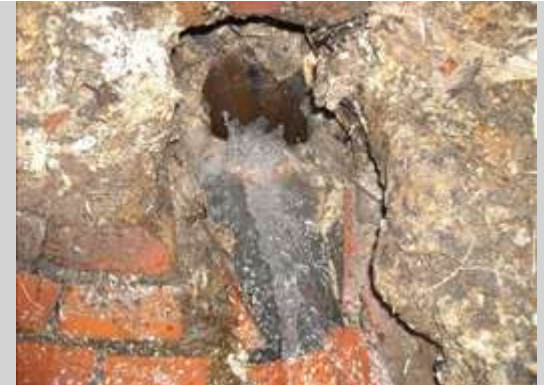
12 O'Clock Outflow

Pipe Height: **8.4** (in.) Rod and Bar (Angled)
Pipe Material: **Clay** ☐ Pipe Lined
Invert Depth: **11.13** (ft.) Flow Characteristics: **Fast**
Deposits: ☒ None ☐ Mud ☐ Sludge ☐ Debris ☐ Grease
Silt Depth: **4** (in.) Deposits Extent: **Medium**
Infiltration: **None** Pipe Seal Cond: **Broken**

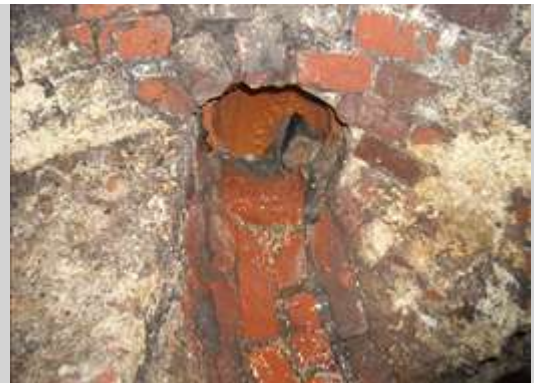
11 O'Clock Inflow

DEBRIS ON BENCH EVIDENCE OF
SURCHARGE ON STEP

Pipe Seal Cond: **Broken**
